THE HIGH MORLAGGAN PROJECT EXCAVATION DATA STRUCTURE REPORT

February 2010

Roderick Regan

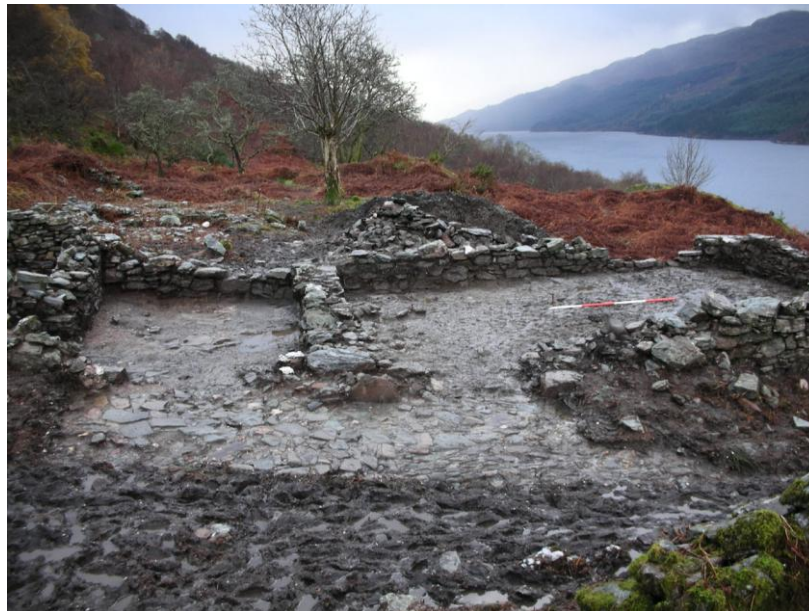
Structure 2 Excavated Building

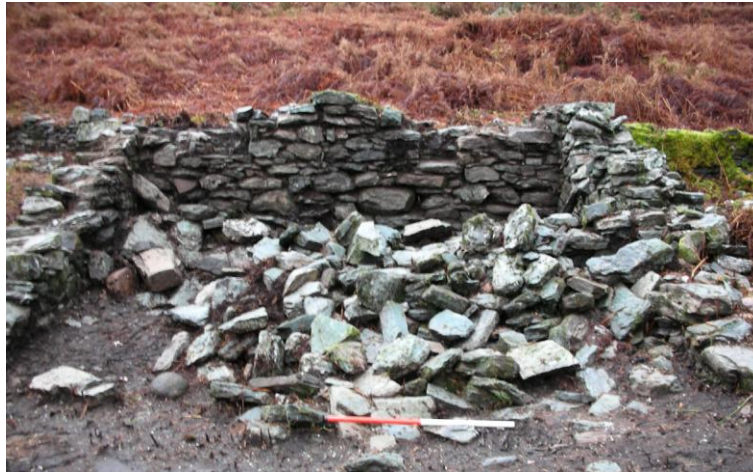
Rubble collapse [002] at east of Structure 2

[003] Layer. Rubble collapse from small rectangular structure and from collapsed E gable end of Structure 2.

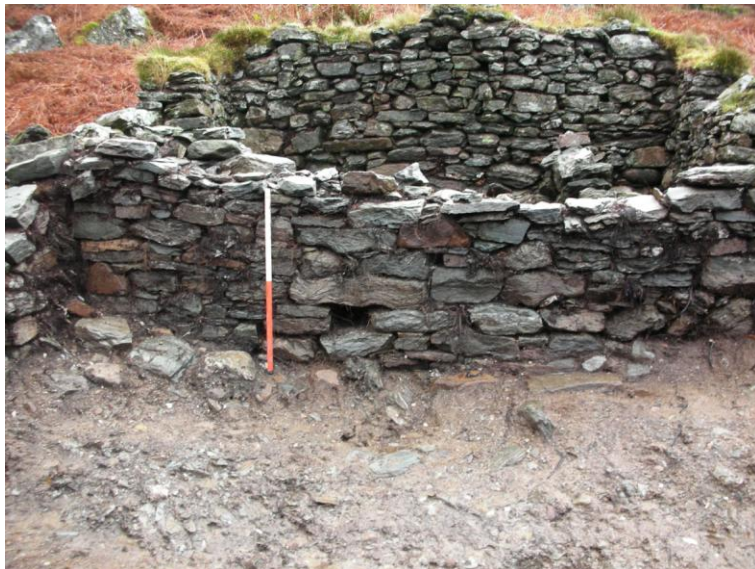
Wall [015]

[015] Wall. Dividing wall within Structure 3. The wall measured 1.35m in visible height and was 0.60-70m wide. It was constructed in drystone rubble the largest block measuring 0.40m long. The wall abuts [011] at N.

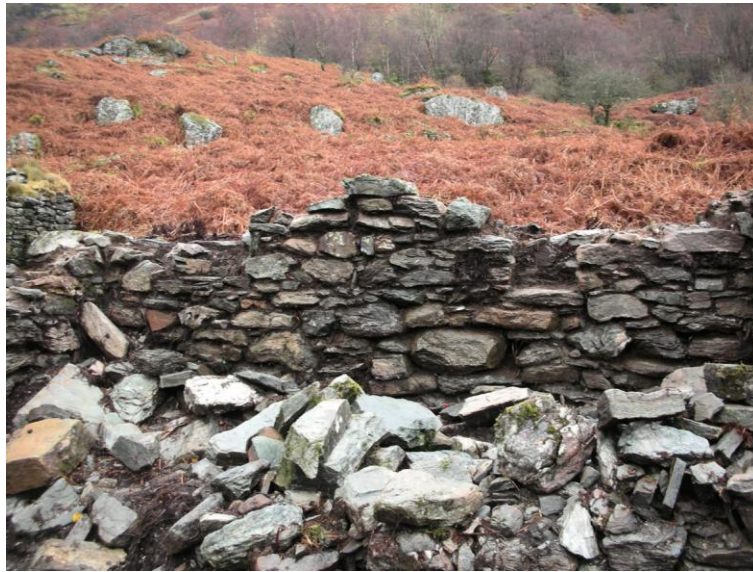
Niches in E wall of Structure 2

[026] Niche. Alcove constructed in E gable of Structure 2. The niche measured 0.48m high, 0.43m wide and 0.30m deep.

[027] Niche. Alcove constructed in E gable of Structure 2. The niche measured 0.31m high, 0.40m wide and 0.36m deep.

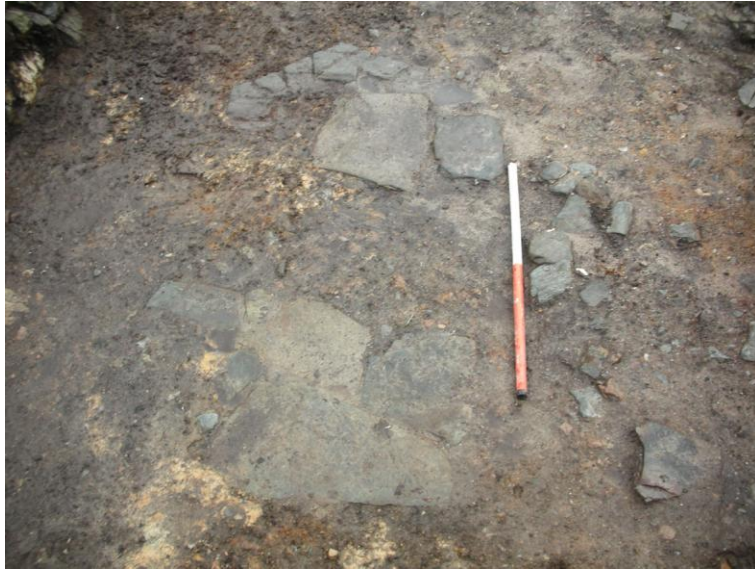
Flagstone surface/possible Hearth setting [033]

[033] Floor. Flagstone surface within E room of Structure 2. The largest flag (of chlorite schist) measured 0.70m and 0.40m. The flags partially covered the W side of the room and may have formed a hearth setting, although there was no visible fire reddening on the stones.

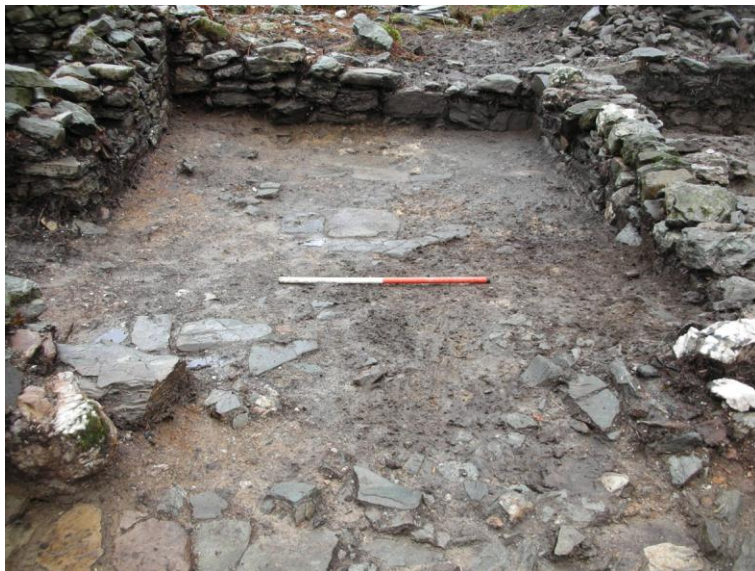
Floor surface in Structure 2

[034] Floor. Compacted surface within E room of Structure 2. This consisted of an orange/brown silty clay gravel with patches of lighter yellow clay (possible repair).

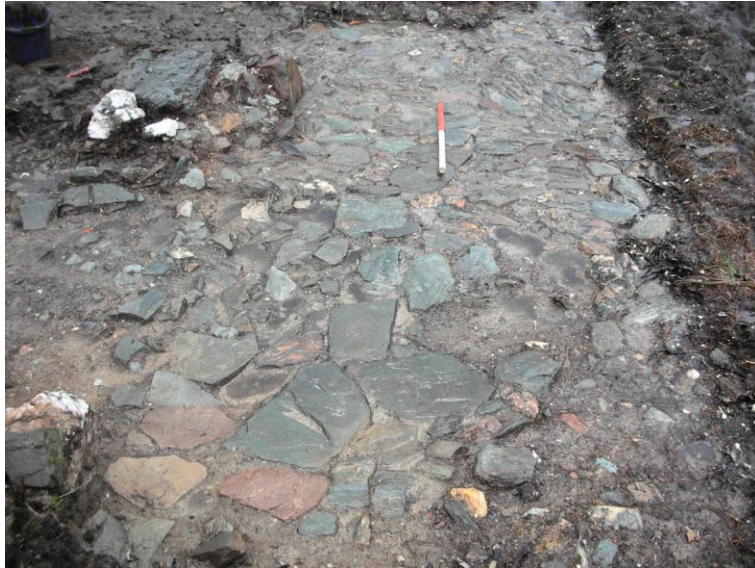
Cobbled Surface [035]

[035] Surface. Compacted and well laid cobbled surface running down the N side of Structure 2. The surface slopes down to the W and N away from the presumed entrance of the Structure and is mainly comprised of mixed stone type water rolled stones (these possibly collected from the beach or from glacial terraces below the settlement?). The largest exposed stone measured 0.45m by 0.32m and the surface stones show signs of extensive wear.

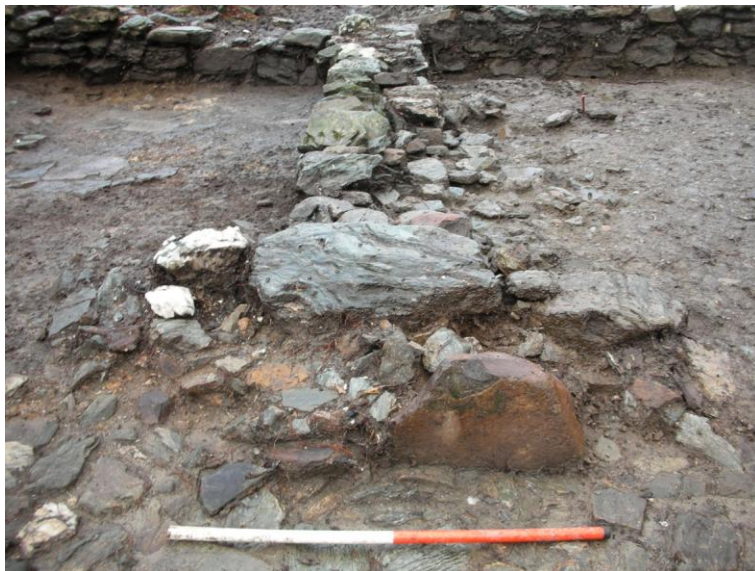
Diving wall [031] with added coping stones [036]

[031] Wall. Dividing wall within Structure 2. The wall measured 0.79m in visible height in 3 courses and was 0.63m wide. It was constructed in drystone rubble and appears to have been robbed and then later added to as [036].

[036] Wall. A single alignment of coping stones added to the top of wall [031].

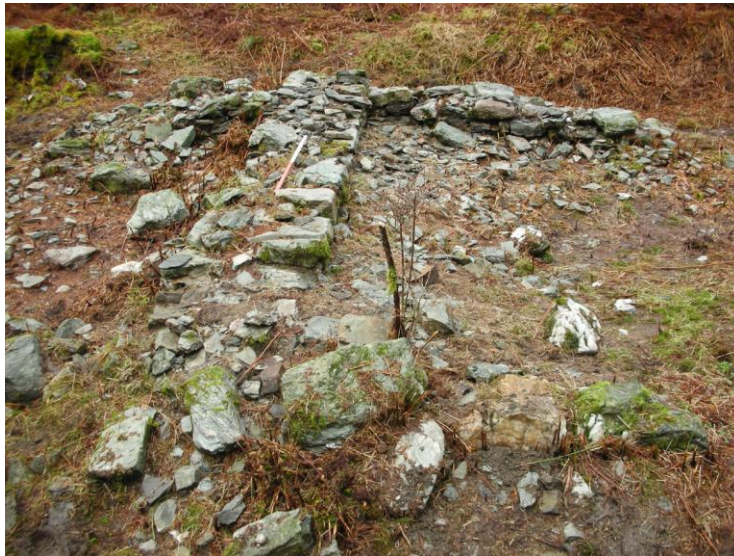
Structures 1 and 1a

Structure 1: This building measured 7.2m by 5.0m externally and was orientated SSW-NNE with a doorway facing WNW. There appears to be a cobbled area outside the doorway. Its external walls were about 0.7m thick and there is evidence of cement rendering on the outside of the walls. There is a small rectangular addition, Structure 1a, on the outside of the NNE wall measuring 1.8m by 2.8m. Attached to the SSW wall is an irregular, roughly circular, enclosure that encompasses large natural boulders in its circuit. It encloses a terraced plot measuring 22m-26m in width (approx. 95 sq. m).

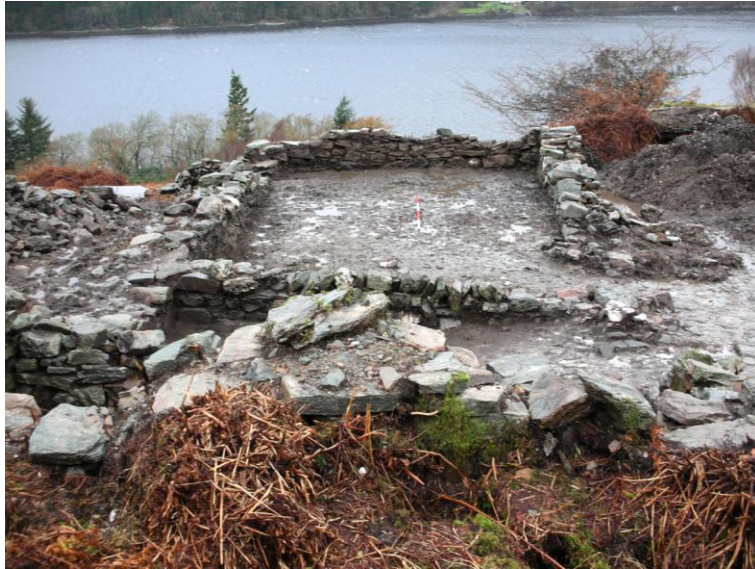
Structure 2

Structure 2: This rectangular building measured 14.6m by 5.6m externally and was orientated WNW-ESE, with two possible entrances on the NNE side. The external walls are about 0.8m thick. There is a low, internal partition wall across the width of the building dividing the building into two rooms. The E room measured 5.8m by 4.4m internally and appeared to have a doorway in its SE corner (this now blocked).

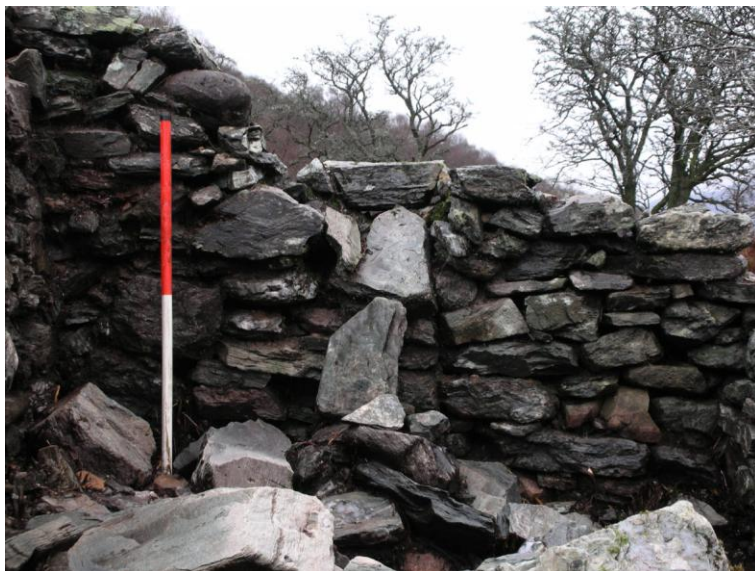
Blocked doorway

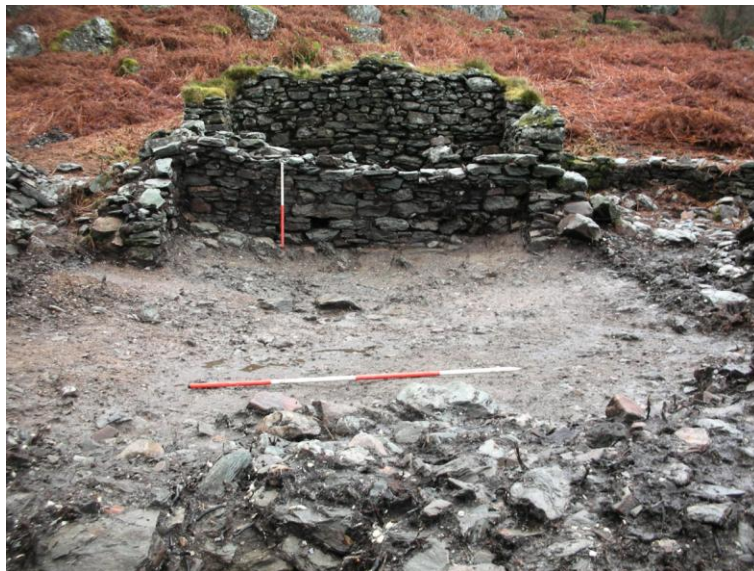
Structure 3 looking east

Structure 3: This rectangular structure measured 11.0m by 5.5m externally and is orientated N-S, with a doorway at the SE and a possible window in the NE wall. Its external walls are about 0.80m thick and stood to a visible height of 1.90m. The building has been extensively robbed especially at the W end.

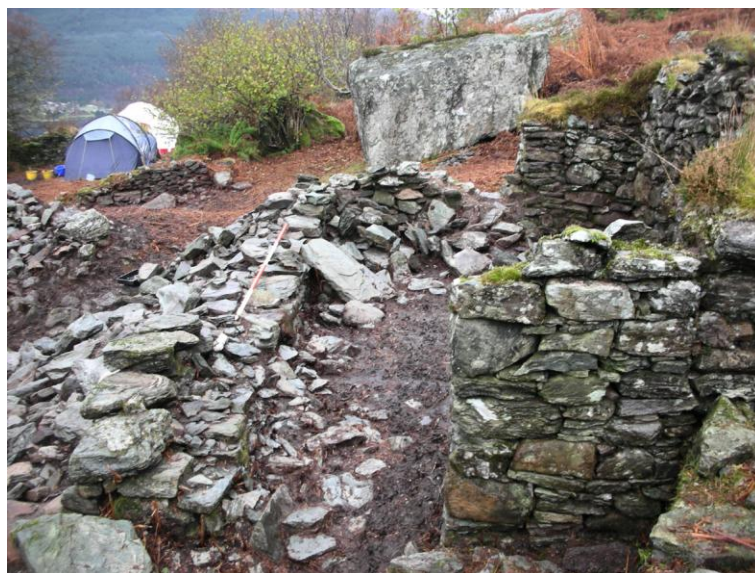
Structure 3 western modification

The remaining structure at the E end of the original building appears to be a later modification. This room or space measured 4.3m by 3.0m internally and was created by the construction of a dividing wall with a narrowing of the original entrance at the S side. An aperture was built into this dividing wall and this may represent a drain outlet into the lower W side of the building. The latest addition to the building was a roughly constructed internal partition wall in the SE corner of the structure measuring 1.0m by 1.6 m, this likely a twinning pen..

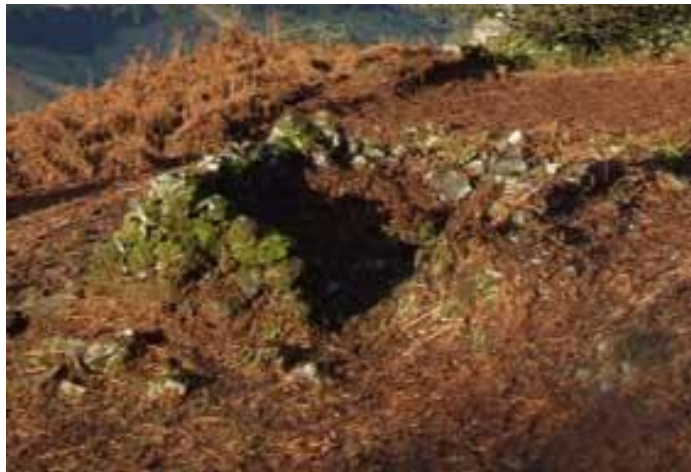
Structure 4

Structure 4: This slightly irregularly shaped building measured 4.0m by 3.8m externally and was orientated N-S. The stone work is of poorer quality, compared with other buildings and the ESE wall is slightly longer than the opposite WNW wall, with corners not at right angles. The walls are about 0.6m thick. There is an entrance in the SSW corner.

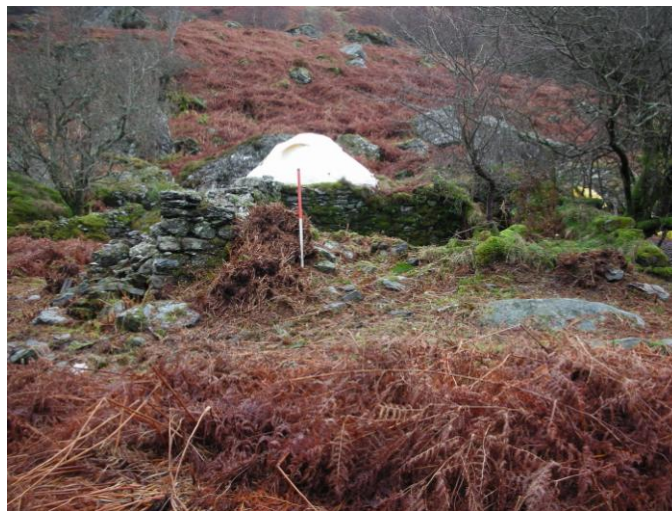
Structure 5

Structure 5: This almost square building measured 5.8m by 5.8m externally, and was orientated N-S with an entrance in the W wall and a possible window in the S wall. The external walls are about 0.7m thick. A small rectangular structure, Structure 5a, approx 1.4m by 4.0 m lies outside the N wall. A roughly rectangular plot bordered by a stone wall surrounds the building, joined to the NE and SW corners, with an entrance to the W, adjacent to the building. The plot (including the house) measured about 19m by 14m (approx. 260sqm. and its enclosing wall incorporates some large, natural boulders.
